Technical Bulletin

Subject: Fuel Injectors, Unnecessary Replacement

Number: 05-02

Date: Apr. 12, 2005

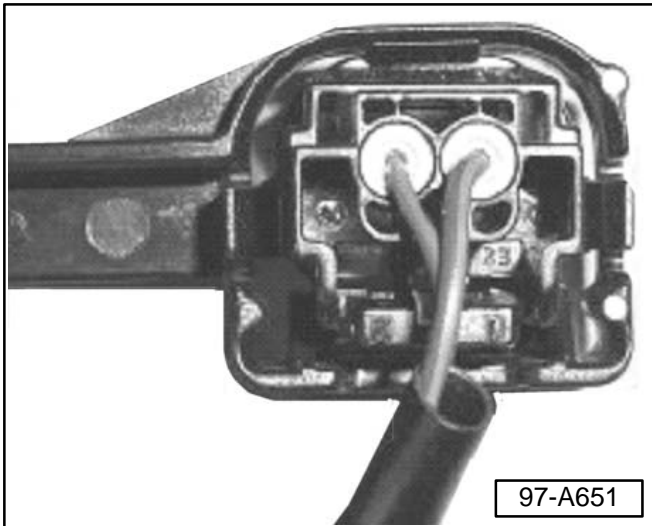
97-A651

- ◀ - Disconnect connector of fuel injector(s).
- Remove contact pins from the plug housing:

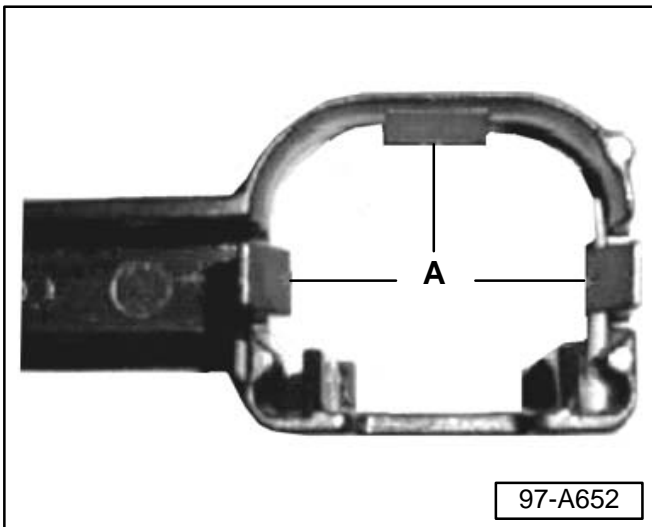
97-A652

- ◀ - Push plug out of housing by releasing locking tabs -A-.

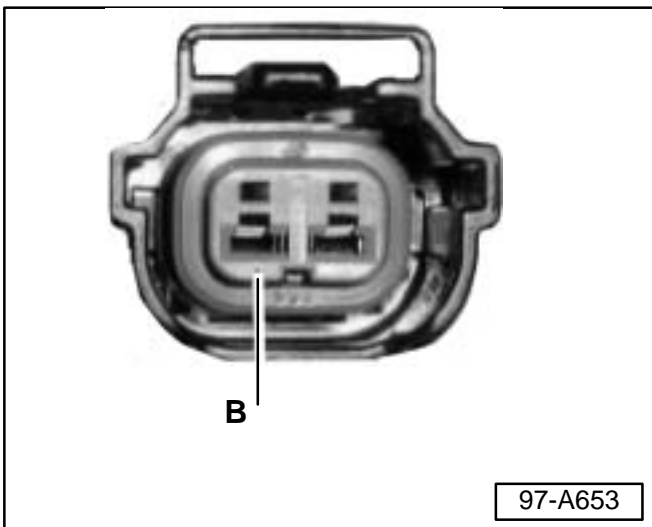
97-A653

- ◀ - Remove secondary lock -B- upwards

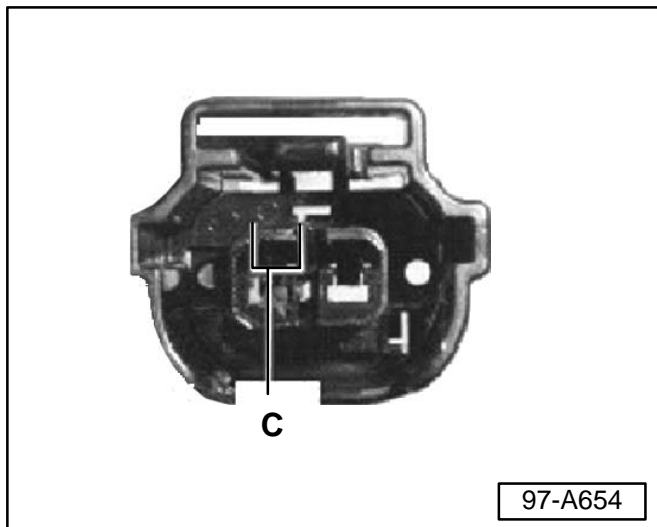
- ◀ – Push tool into slot -c- and remove female terminals from connector.
