**Audi**

# Technical Bulletin

Subject: Exterior Lights, Moisture Accumulation

Number: 05-04

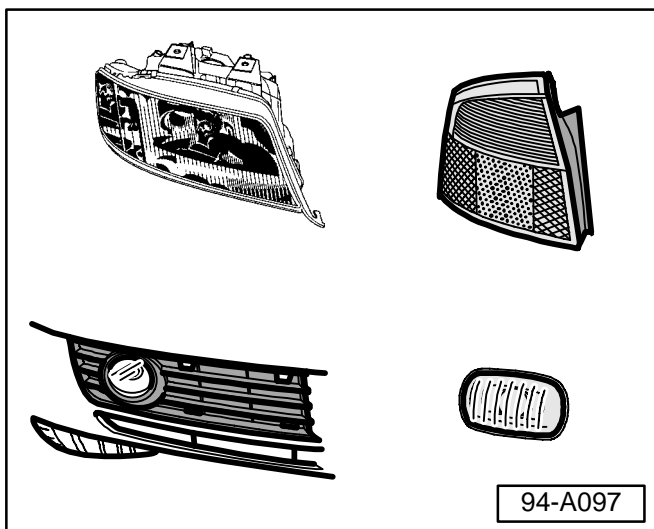
In cases where larger water droplets have formed on the inside of the lens or significant amount of water has collected at the bottom of a light assembly:

If no damage is found, use compressed air (less than 30 PSI ) to blow out the lens.
